Investigation of Steel-Stringer Bridges: Superstructures and Substructures, Volume II

Final Report
October 2007

Sponsored by
the Iowa Highway Research Board (Project TR-522)
and the Iowa Department of Transportation (CTRE Project 04-184).

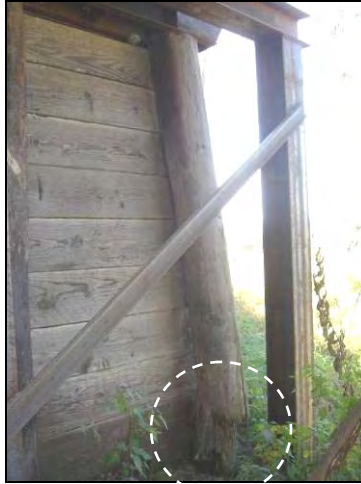
Physical deterioration, which can exist in many forms such as severe cracks and splits, reduction of pile cross section by abrasion, broken piles, and brooming of the pile was also apparent at many sites. Cracks and splits near the pile top can occur while driving the pile, and can result in exposing the untreated pile core to insects and bacteria. An example of commonly observed pile cracks is shown in Figure 4.2. Flowing debris and ice are other factors that contribute to pile physical deterioration, and can result in reduction of pile cross section by abrasion as shown in Figure 4.3. Overloading the piles was observed at 20% of the inspected substructures. Overloading, which is mostly caused by failure of adjacent pile(s), can result in compression failure of the pile and separation of the top portion of the pile as shown in Figure 4.4a. Compression failure can also be in the form of bulging of wood fibers or “mushrooming” at a hollow pile section (See Figure 4.4b and c).

(a) Separation of pile section (Bridge No. 23-70-00 Mahaska County – July 8 2005)

Figure 4.4. Compression failure of pile section caused by overloading

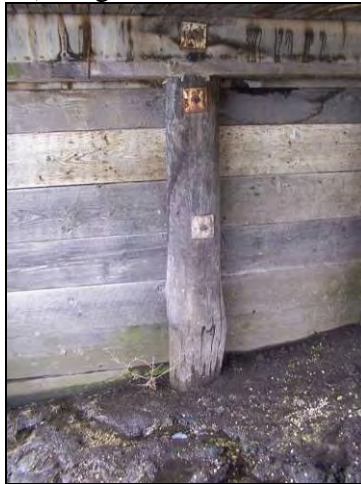
(b) Bulging of timber fibers (Bridge No. 35-87-00 Buchanan County – February 15 2005)

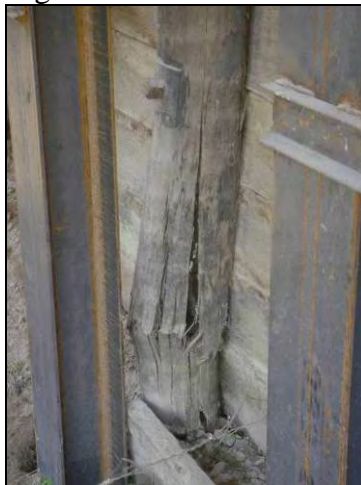
(c) “Mushrooming” of fibers at a hollow section (Bridge No. 23-70-00 Mahaska County – July 8 2005)

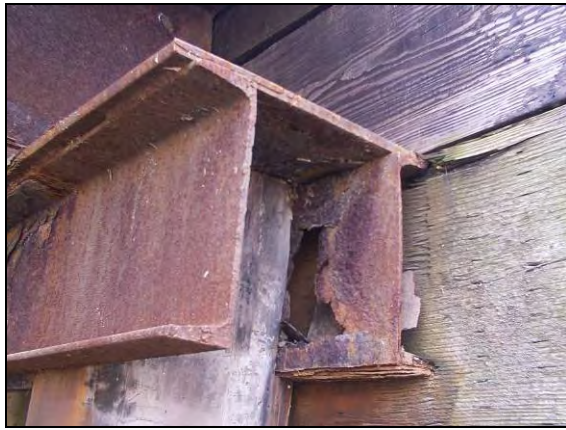
Another observed form of substructure degradation was deterioration of pile caps. A corroded steel cap is presented in Figure 4.7a, while a biologically deteriorated timber cap is shown in Figure 4.7b. Deteriorated pile caps can result in poor load-bearing characteristics and overloading of adjacent piles.

(a) Corroded steel
(Bridge No. 1045 Black Hawk County
– April 2 2005)

Figure 4.7. Deterioration of pile cap

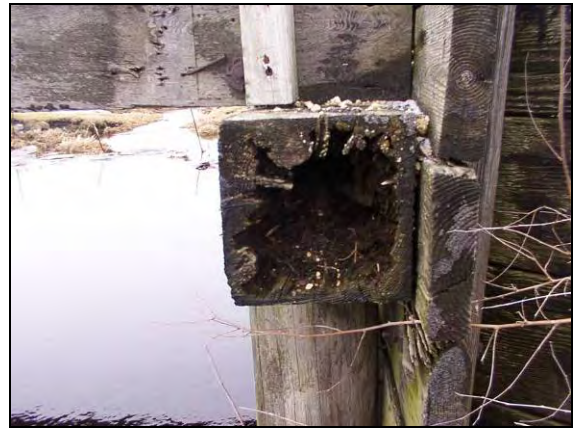
(b) Biologically degraded timber cap
(Bridge No. 15-00-62 Buchanan County
– February 15 2005)

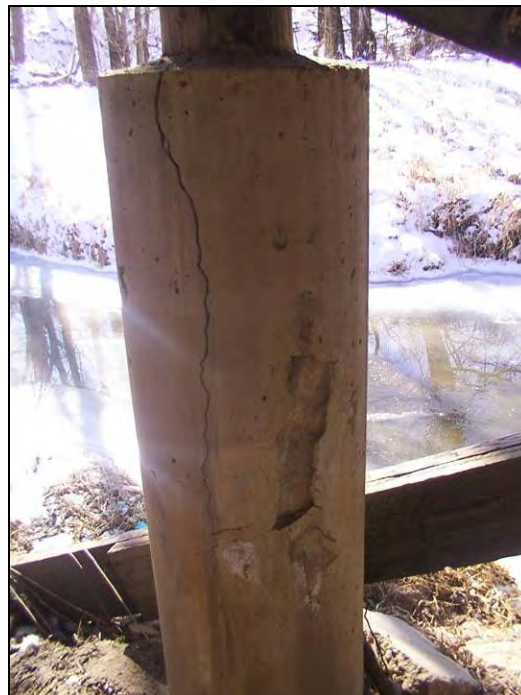
Figure 4.9. Spalling and cracking of concrete casing (Bridge No. 149 Boone County – February 11 2005)

- Longitudinal cracks and concrete spalling are common distresses associated with concrete casing.
- A new timber or steel pile is driven next to the faulty pile when deterioration is excessive and is localized in one pile.

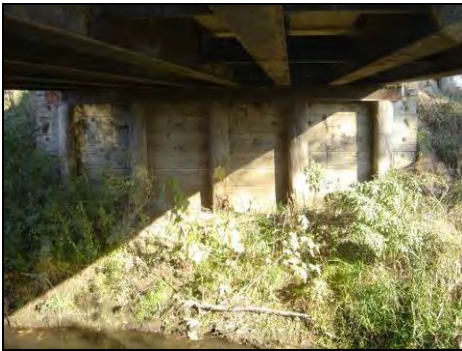
In one bridge in Tama County, IA, complete replacement of an existing timber abutment with a new timber abutment system was documented. Replacement was conducted because of severe deterioration at both the north and south abutments. Several deterioration problems were identified at the north abutment such as brooming of the pile section due to overloading, soft section near the ground level with high moisture content, and hollow pile section caused by biological decay (See Figure 4.11). To drive new piles, a section of the concrete deck was removed and about 20 ft of the gravel road near the backwall was excavated (Figure 4.12). Four temporary timber piles (two on each side) were driven adjacent to the sides of the bridge and steel beams were placed on top of them under the existing girder to support the bridge as the

(a) Overview of the north abutment before replacement

Figure 4.11. Bridge No. 31-72-50 Tama County – October 27 2005

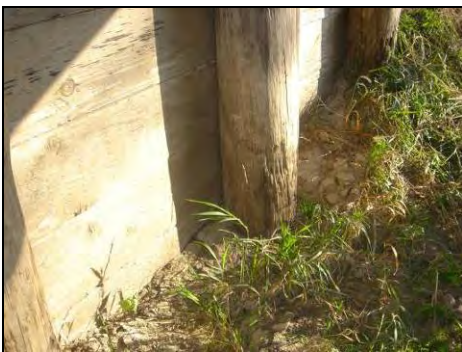
(c) Soft pile section with high moisture near the ground level

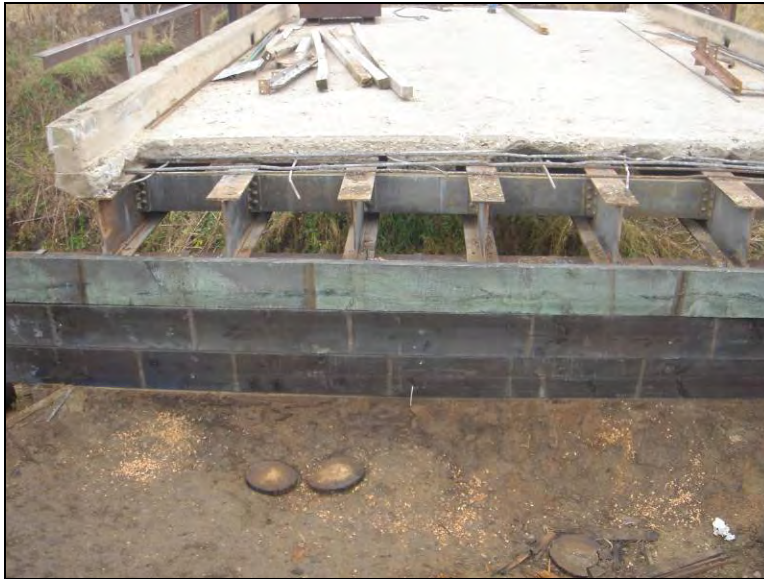
Figure 4.12. A section from the concrete deck is removed for driving timber piles (Bridge No. 31-72-50 Tama County – September 8 2005)

deteriorated piles were cut short. The new timber piles were driven next to the existing ones and a new timber pile cap was placed under the girders and connected to the new piles. The supporting beams were removed and the old and temporary piles were left in place (Figure 4.13). Leaving the deteriorated piles in place diverts the biological decay away from the new piles, however, it is still recommended to treat the causes of biological decay if the new piles are timber. As an alternative, steel piles can be used for maintenance as shown in Figure 4.14.

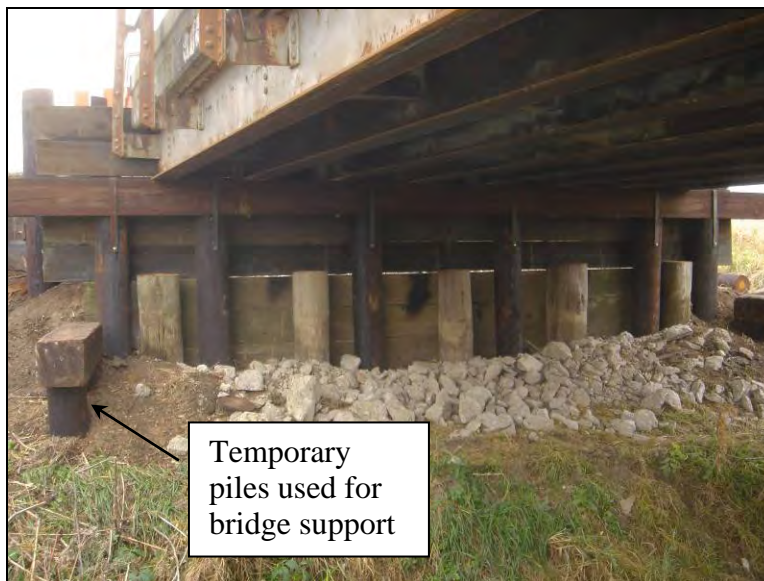
Figure 4.13. New timber abutment system constructed at the north side (Bridge No. 31-72-50 Tama County – September 8 2005)

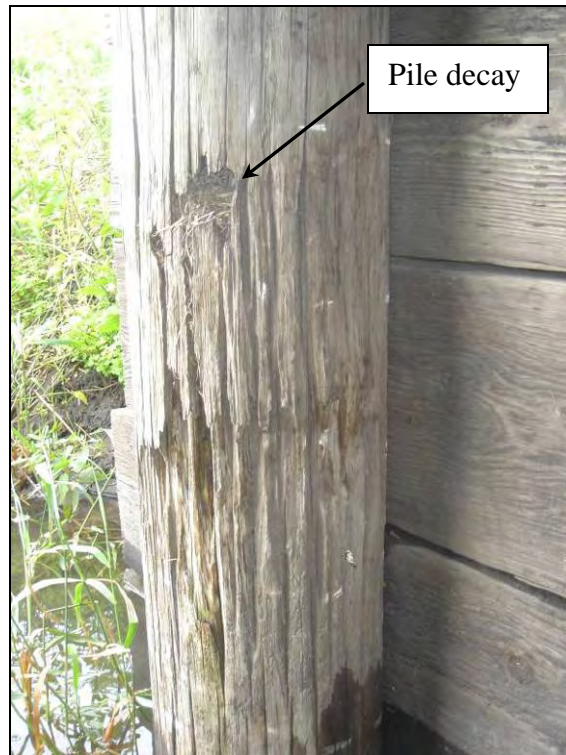
Figure 7.6. Deterioration at pile No. 1 (Bridge No. 7710 Boone County – July 1 2005)

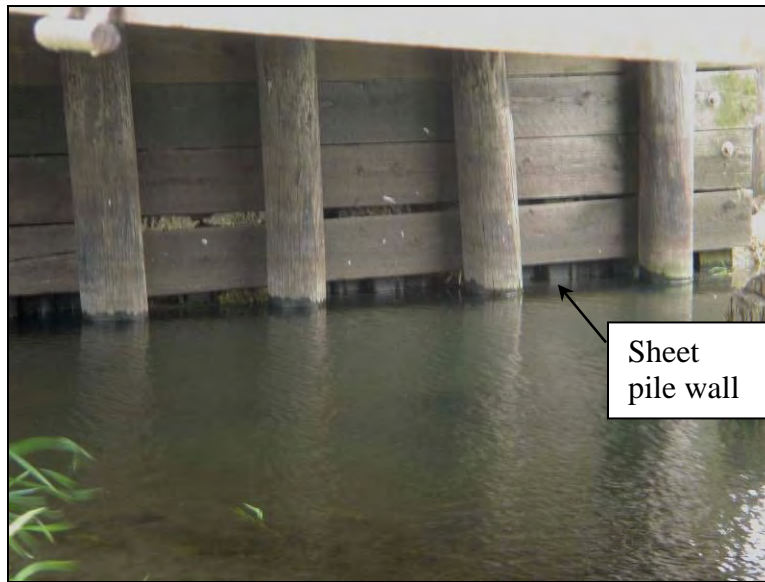
Each abutment is comprised of seven timber piles about 7 inches in diameter, a timber backwall, and a double c-channel cap (See Figure 7.2). The average exposed length of the piles above the water table was about 50 inches. The pile length below ground level is unknown since no bridge plans were available. The piles at the north abutment were denoted as no. 1 located at the northwest edge of the bridge, through no. 7 as shown in Figure 7.3. The dimensions of the north abutment are shown in Figure 7.4. A schematic diagram of the abutment, shown in Figure 7.5, indicates that the bridge does not have a conventional stub-abutment detail; the girder ends are integrally connected to a concrete diaphragm, which rests directly on top of the pile cap. This integral connection complicates the substructure analysis due to the difficulty in quantitatively, isolating, and understanding its effect on load distribution through the substructure components. Inspection of the north abutment revealed decay at pile no. 1 about 32 inches above the water level (See Figure 7.6). Also, a soft pile section right above the water table was observed at pile no. 7 as shown in Figure 7.7. The soft section may be a result of high levels of moisture due to the variation of the water table, which in turn triggers biological activity. Excessive scour occurred near the south abutment undermining the timber backwall. This led to exposure and erosion of the backfill material creating a void behind the backwall. In 1993, as shown in Figure 7.8, a sheet pile wall was driven behind the south abutment to prevent further erosion; the erosion-induced void was filled with concrete.

Figure 7.8. Sheet pile wall driven behind the south abutment to prevent backfill erosion (Bridge No. 7710 Boone County – June 1 2005)

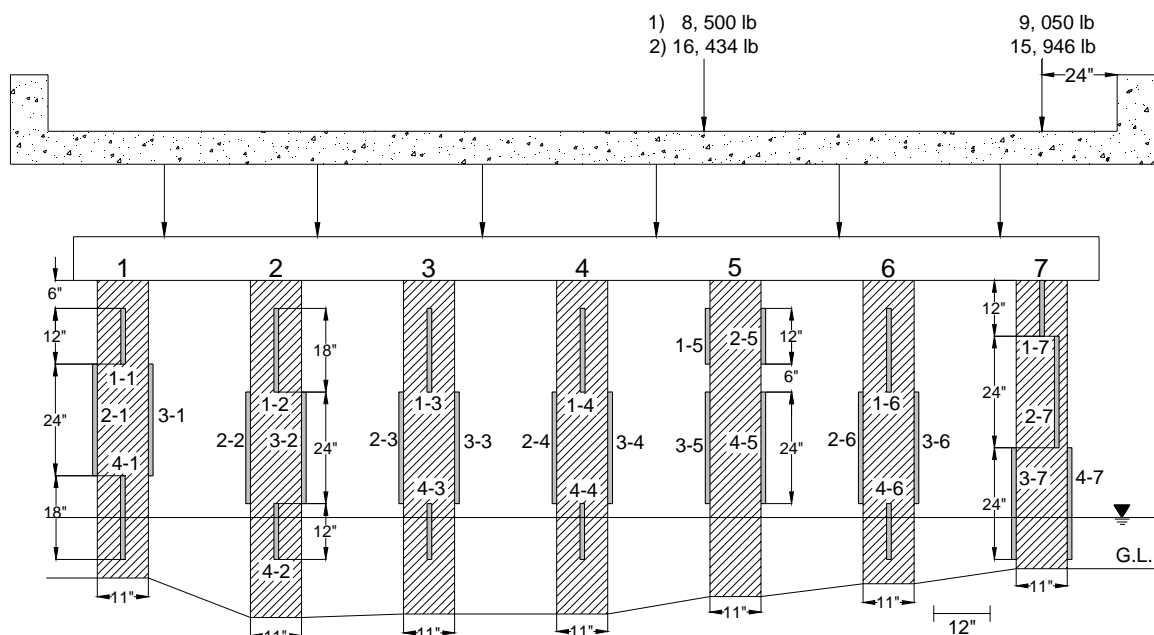
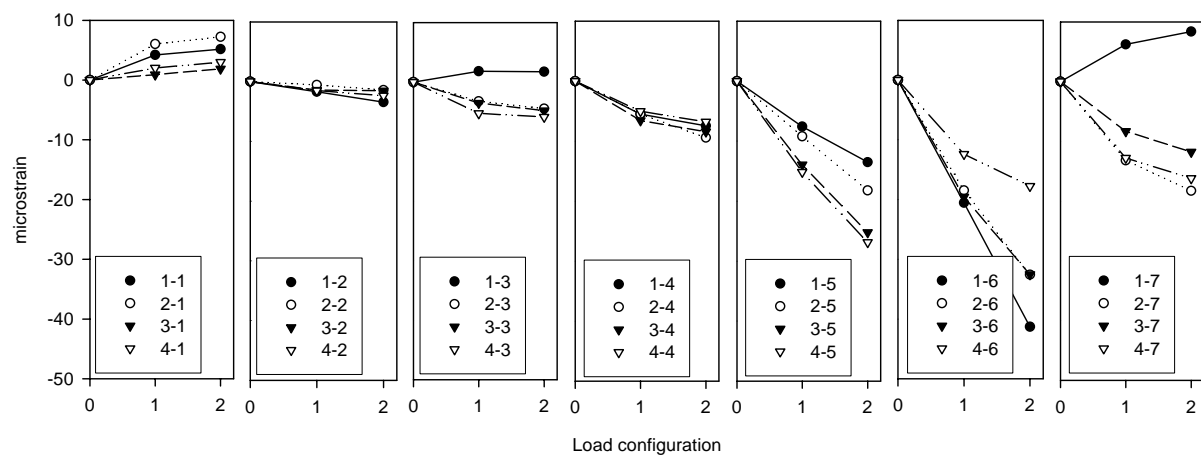
In the third test conducted, load was applied at the east edge of the bridge. The strains and the locations of the applied loads are shown in Figure 7.12. The highest strains were measured in pile no. 6. One interpretation of the high strains is the transfer of axial load from the adjacent pile no. 7 due to the soft pile section observed at the water level (Refer to Figure 7.7). The strain transducer attached to pile no. 7 (denoted by 1-7) measured positive strain values. As shown in Figure 7.13, the pile cap is not aligned over the centerline of pile no. 7 and is partially resting on the backwall. This may have produced eccentric axial loads, which may lead to pile bending and hence positive strains in the upper portion of the pile. The same observation was noted when the abutment was previously loaded at the centerline of the bridge. All strains measured in pile no. 1 were positive. This indicates that pile no. 1 was subjected to tension due to a net uplift force on the west edge of the pile cap.

Figure 7.12. Pile strains at the north abutment – East edge (Bridge No. 7710 – Boone County)

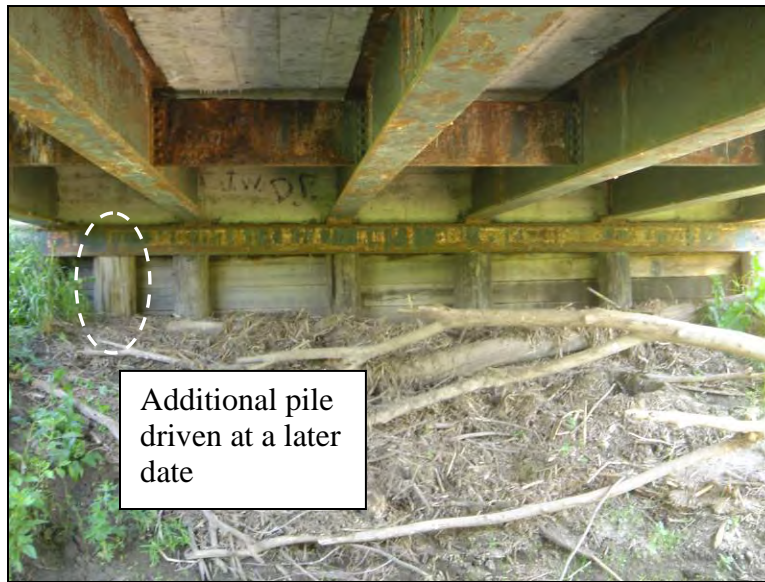
Figure 8.3. North abutment (Bridge No. 243470 Marshall County – July 22 2005)

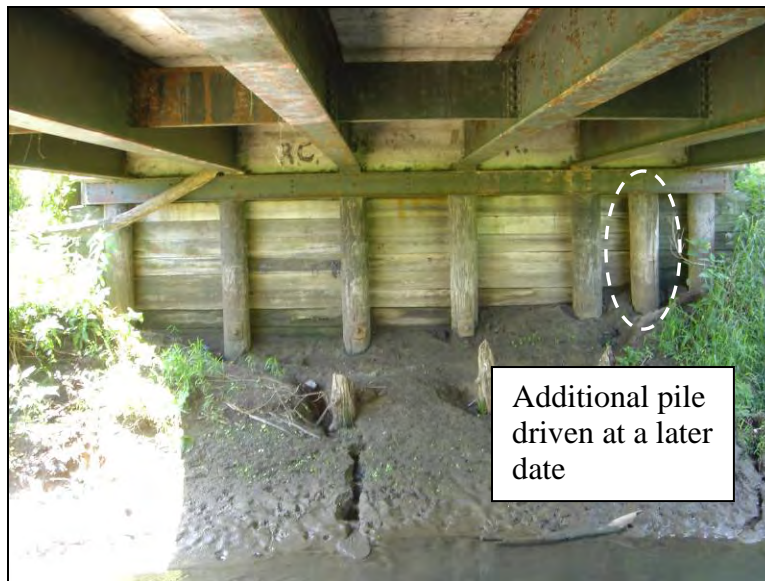
Figure 8.4. South abutment (Bridge No. 243470 Marshall County – July 22 2005)

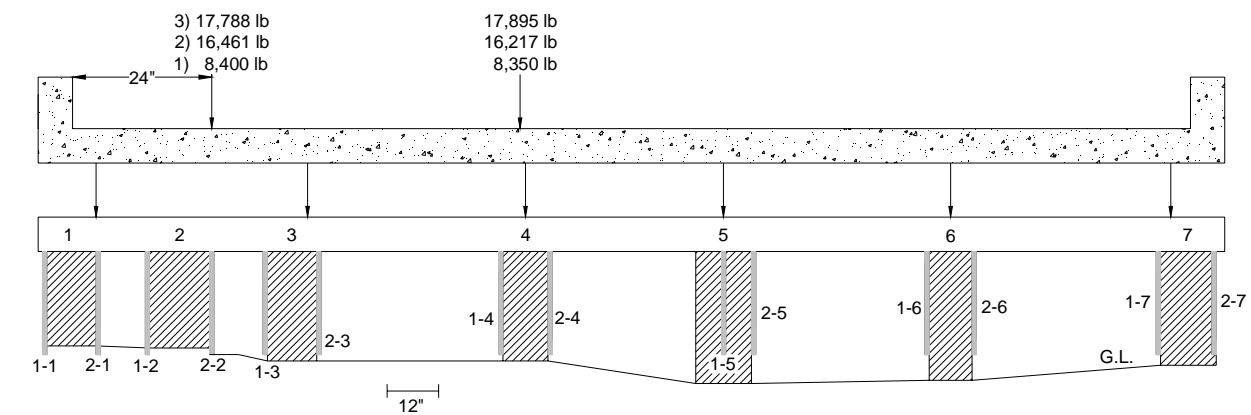
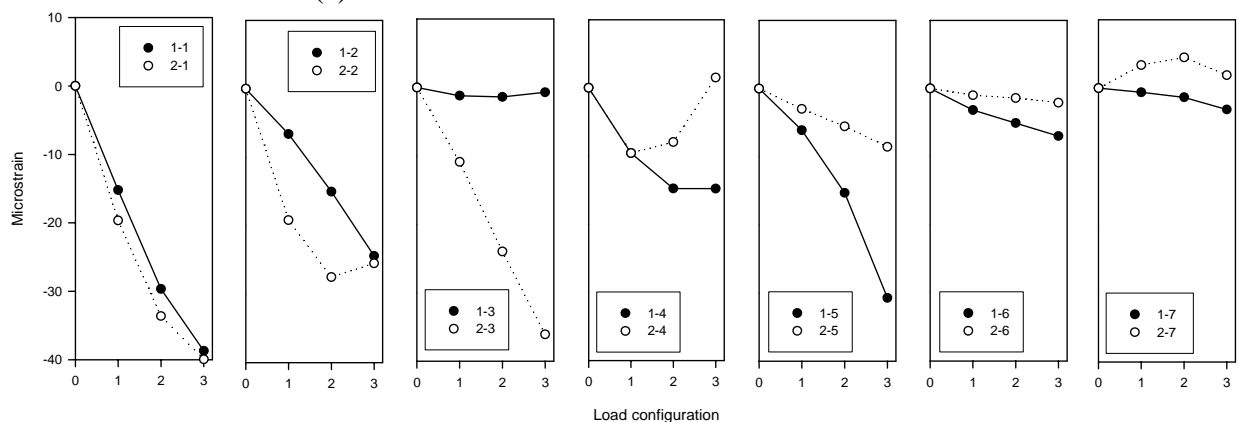
Figure 8.11. Static load test at the west edge (Bridge No. 243470 – Marshall County)

The first static load test conducted was at the west edge of the north abutment. The pile strains and the location of the applied loads are shown in Figure 8.11. The results indicate that the highest strain values for all three load configurations were measured in pile no. 1. At load configuration 3, the strain measured in pile no. 1 was about -39 microstrains.

The strain transducers attached to the deteriorated pile Nos. 2 and 4 showed increasing strain to a certain strain level after which the strain values decreased with increasing load. The overall strain of adjacent pile nos. 1, 3 and 5 increased. Pile no. 7 showed positive strain values.

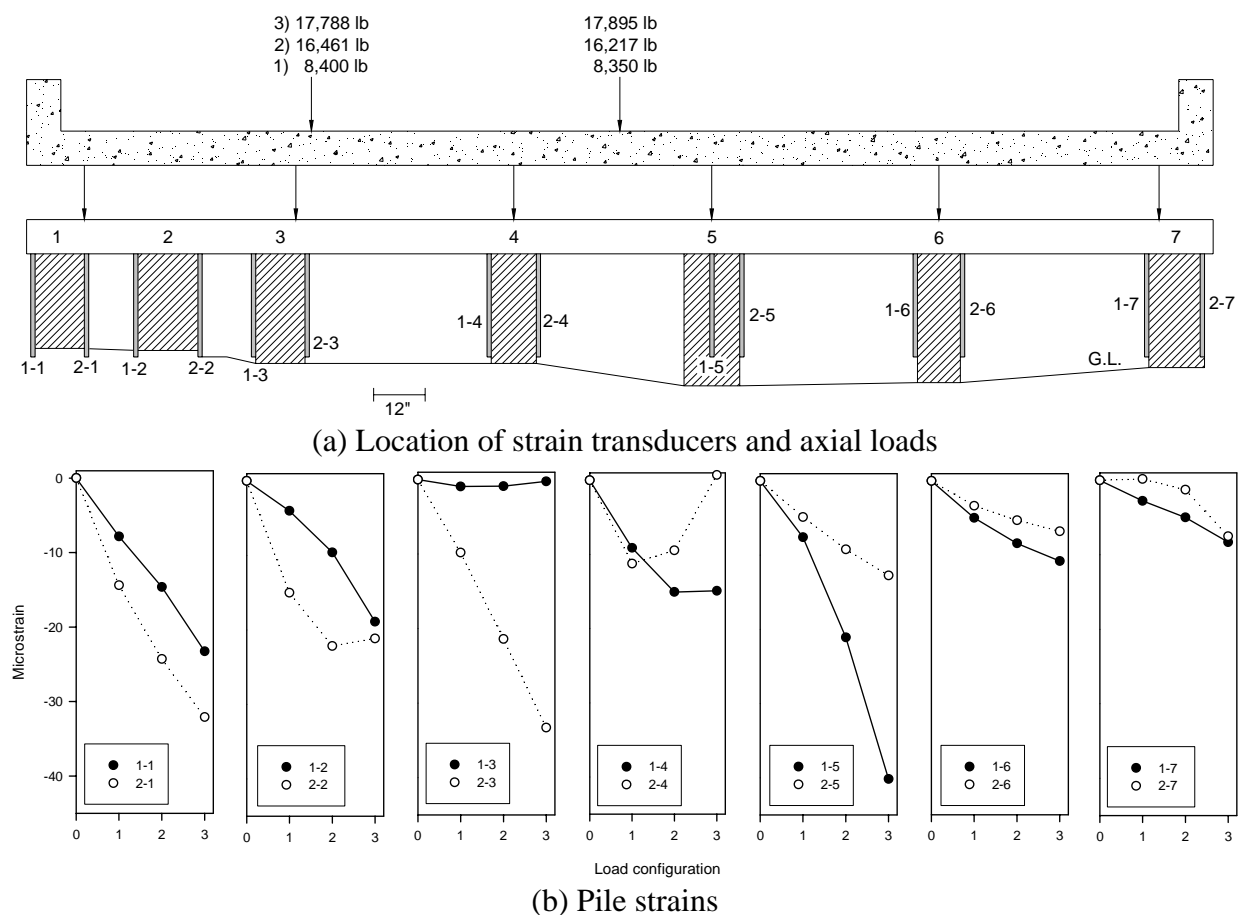
Figure 8.12. Static load test at the centerline (Bridge No. 243470 – Marshall County)

The second load test was carried out by aligning the truck wheel on the centerline of the bridge deck. Location of the applied loads and the pile strains are shown in Figure 8.12. Similar to the previous load test, pile nos. 1, 3 and 5 had the highest strains. Also, the deteriorated pile nos. 2 and 4 demonstrated behavior similar to the previous test where the strains increased initially to a maximum value after which they decreased. The maximum strain value recorded for pile no. 2 was about -27 microstrains. Strain transducer 1-4 increased to a value of -12 microstrains at load configuration 1 and then decreased with increasing load. Strain transducer 2-4 reached a maximum strain value of -14 microstrains at load configuration 2 and remained constant with increasing load. The results from the west edge and the centerline load tests illustrate that strain transducer 1-3 experienced essentially no strain.

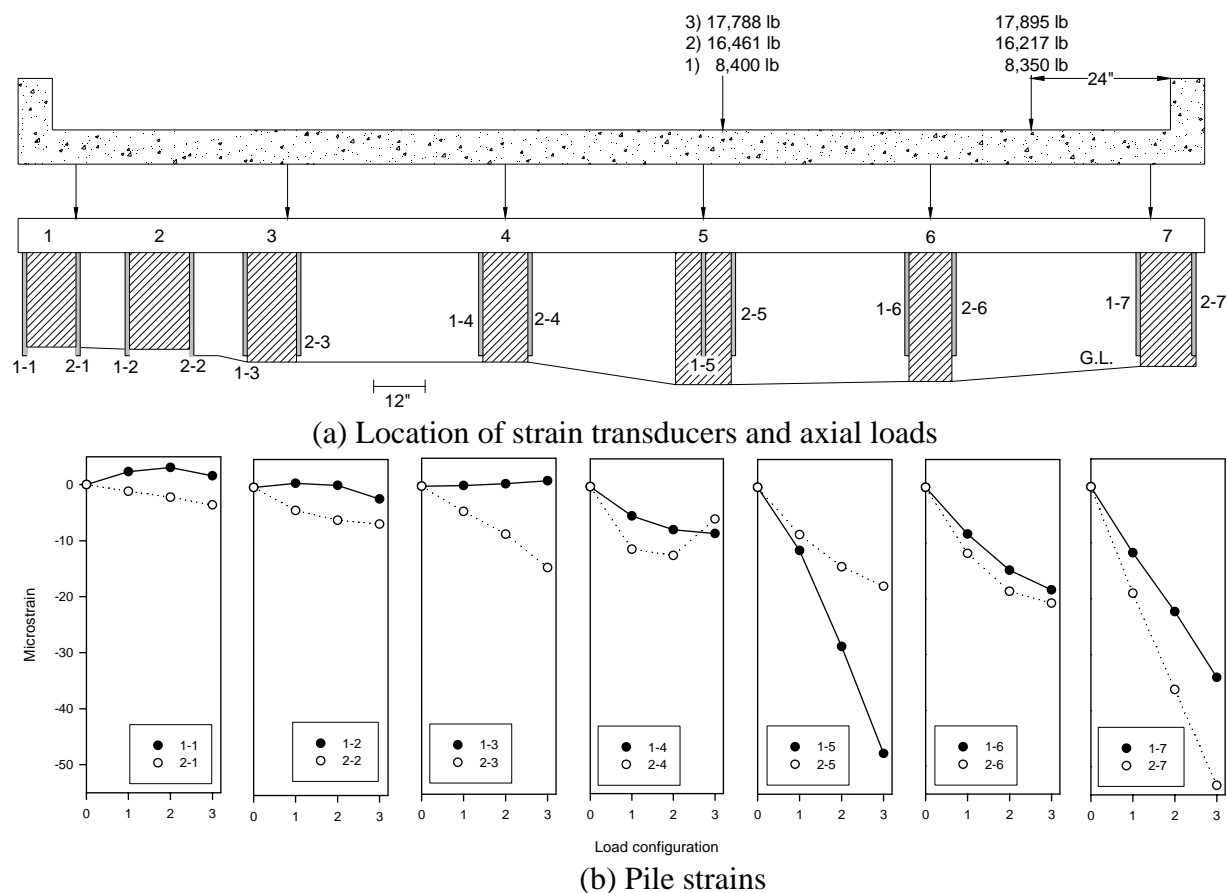
Figure 8.13. Static load test at the east edge (Bridge No. 243470 – Marshall County)

The third load test was conducted with the loading at the east edge of the bridge. The locations of the loads and the piles strains are shown in Figure 8.13. Pile nos. 5, 6 and 7 had the highest strains, which decreased with distance from the applied loads. This demonstrated that the pile cap was acting flexible, which resulted in a non-uniform load distribution through the

substructure. The strain transducers attached to pile no. 4 reached a maximum value of -12 microstrains after which it decreased with increasing load. The strain transducer denoted by 1-1 measured positive strains.

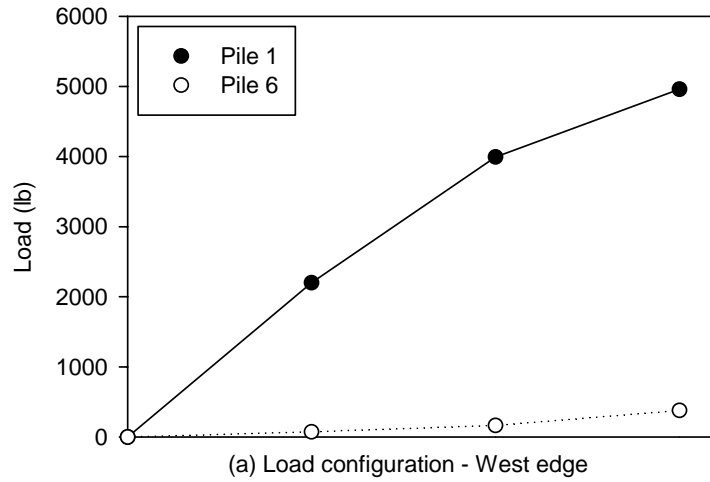
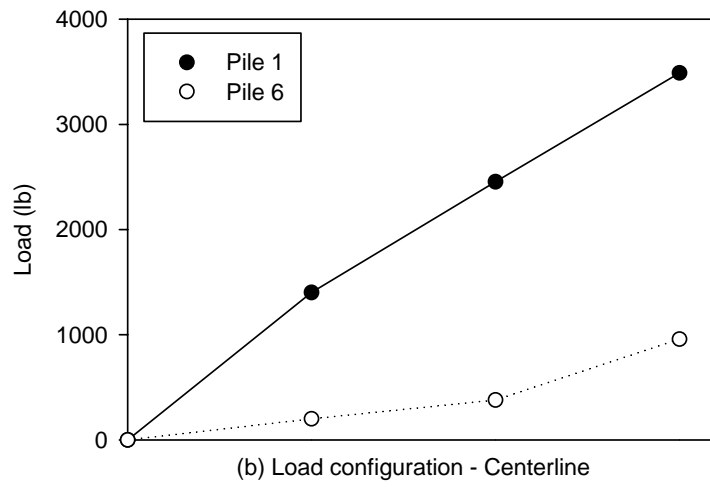
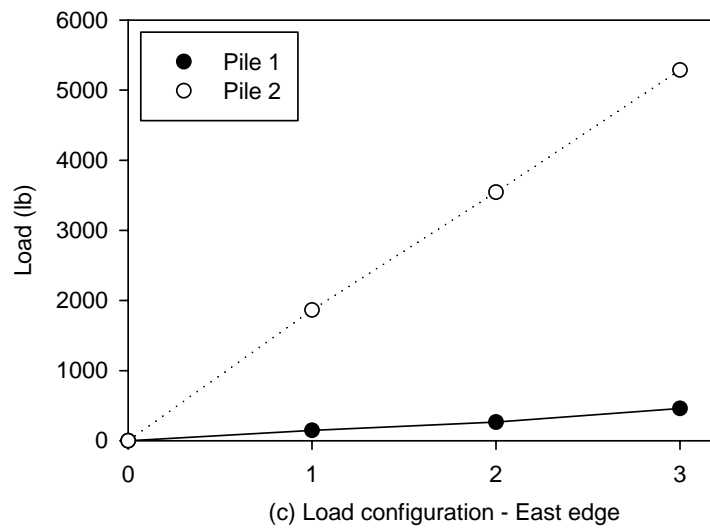
Figure 8.14. Calculated load carried by pile nos. 1 and 6 at the north abutment (Bridge No. 243470 – Marshall County)

Using E determined by conducting axial compression tests, the loads carried by pile nos. 1 and 6 were determined. Table 8.2 summarizes the calculated loads carried by each pile. The results show that the percent load carried by pile no. 1 during the west edge test was about 13% for load configurations 1 and 2 and about 14% for load configuration 3. The load carried by pile no. 6, however, was about 0.4, 0.5 and 1.1% for load configurations 1, 2, and 3, respectively. It was noted that for load configuration 3, where the highest axial load was applied, the percent load carried by the piles increased compared to previous load configurations. This can be explained by load transfer from adjacent deteriorated piles as their maximum load carrying capacity was reached. The loads carried by the piles during the centerline and east edge tests are also shown in Table 8.2. Figure 8.14 is a graphical representation of the loads carried by pile nos. 1 and 6.

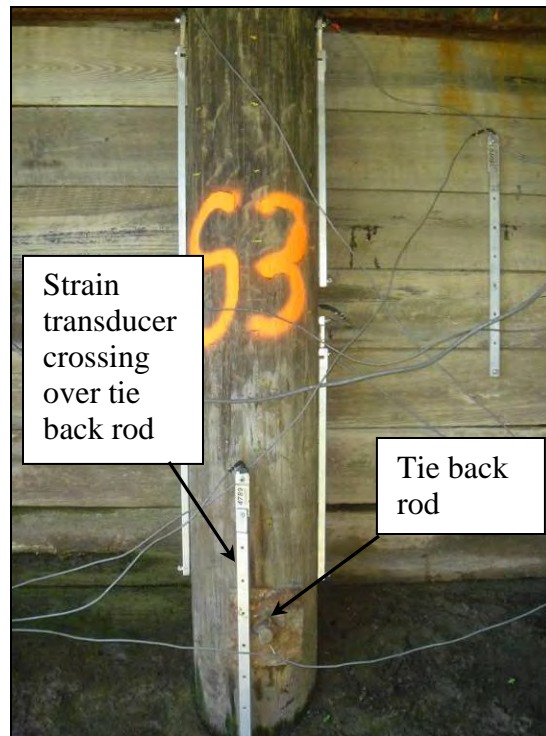
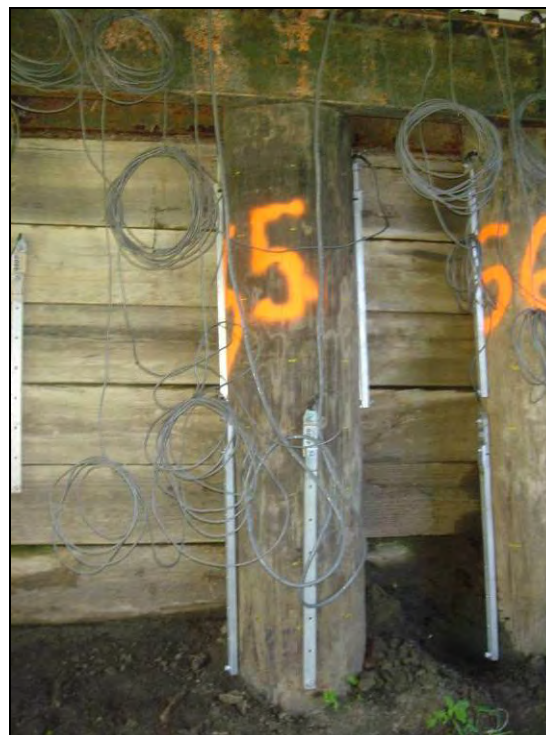
Figure 8.16. Strain transducers crossing over the tie back rod (Bridge No. 243470 Marshall County – July 27 2005)

(a) Pile no. 3 at the south abutment

(b) Pile no. 5 at the south abutment

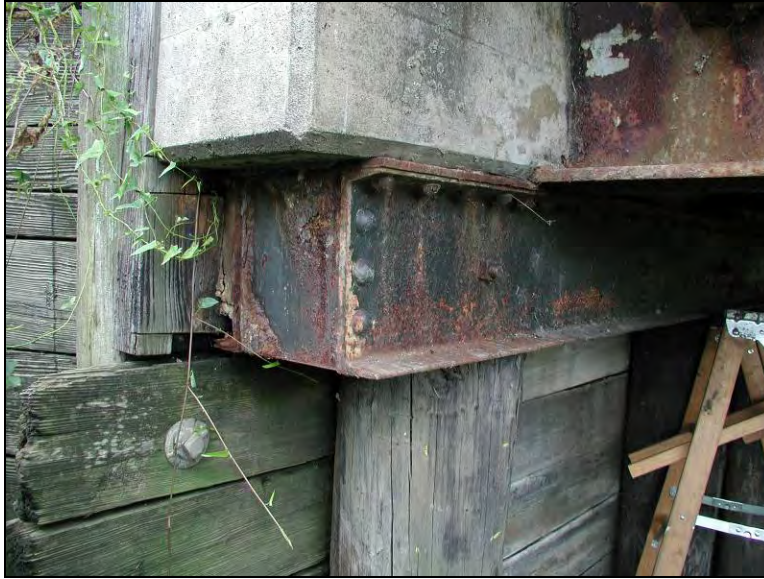
Similar to the pile strains, the backwall strains were higher directly under the live load and decreased with increasing distance from the load location. Figure 8.18 shows the pile cap partially resting on the top of the timber backwall; therefore, the measured negative strains may be a result of axial compression of the backwall.

Figure 8.18. Pile cap partially resting on the timber backwall (Bridge No. 243470 – Marshall County – July 28 2005)

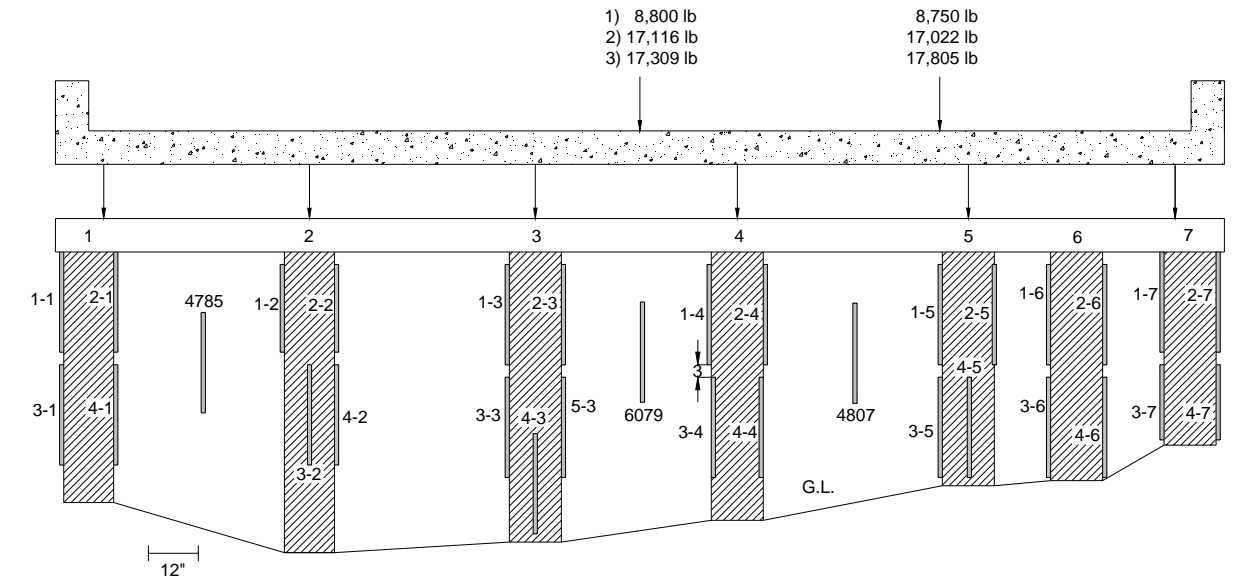
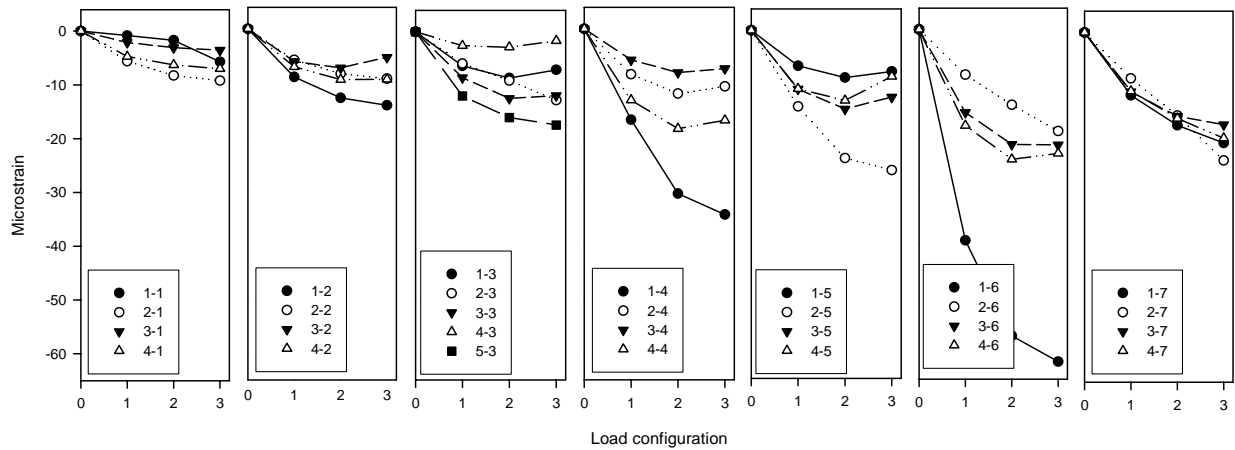
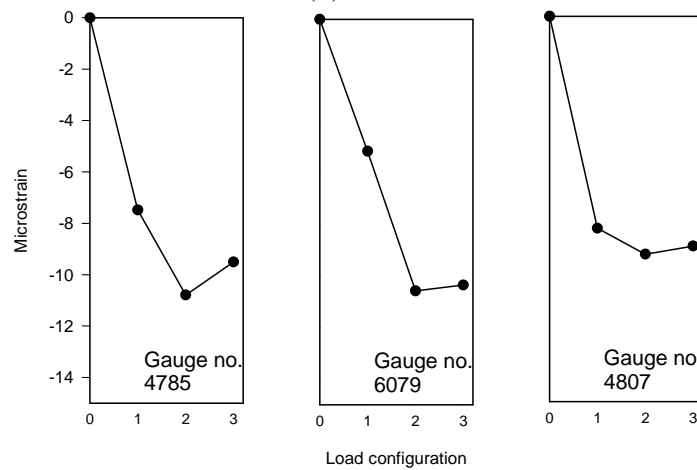
Figure 8.19. Static load test at the centerline (Bridge No. 243470 – Marshall County)

The second load test at the south abutment was completed with the loads at the centerline of the bridge deck. The locations of the applied loads, recorded pile strains, and backwall strains are shown in Figure 8.19. The strains were greatest in pile nos. 4 through 6, and decreased with increasing distance from the applied load. Similar to the previous test, the strain transducer bridging over the tie back rod (transducer 4-3) measured low strains compared to the other strain transducers attached to pile no. 3.

The backwall strains, which were more uniformly distributed compared to the previous test (See Figure 8.19c), were negative during the third load configuration due to the partial bearing of the pile cap on the backwall.

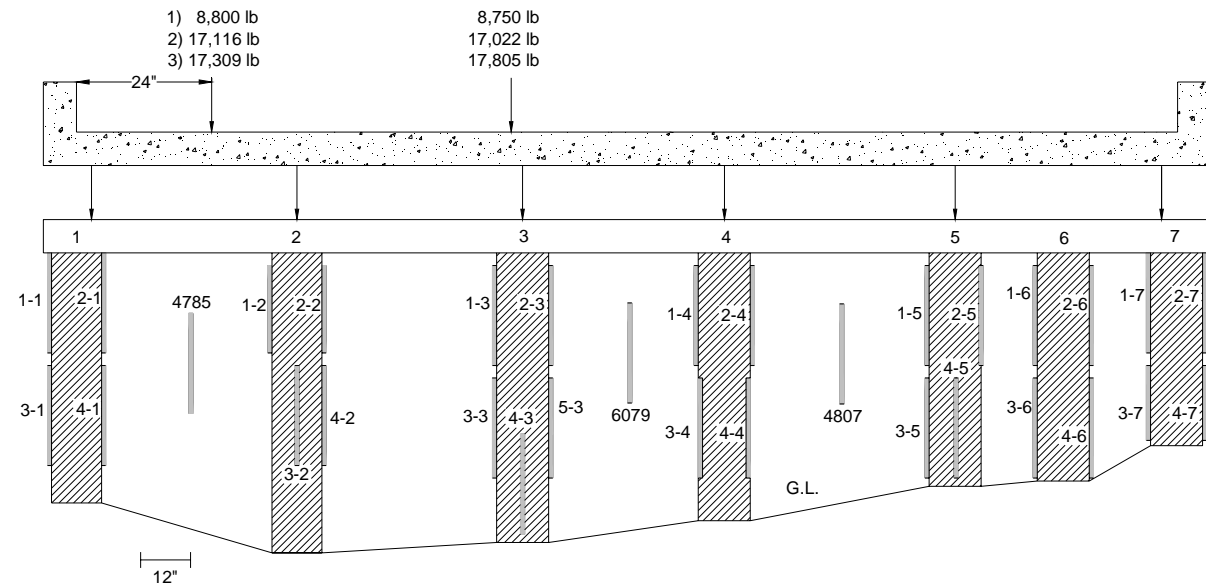
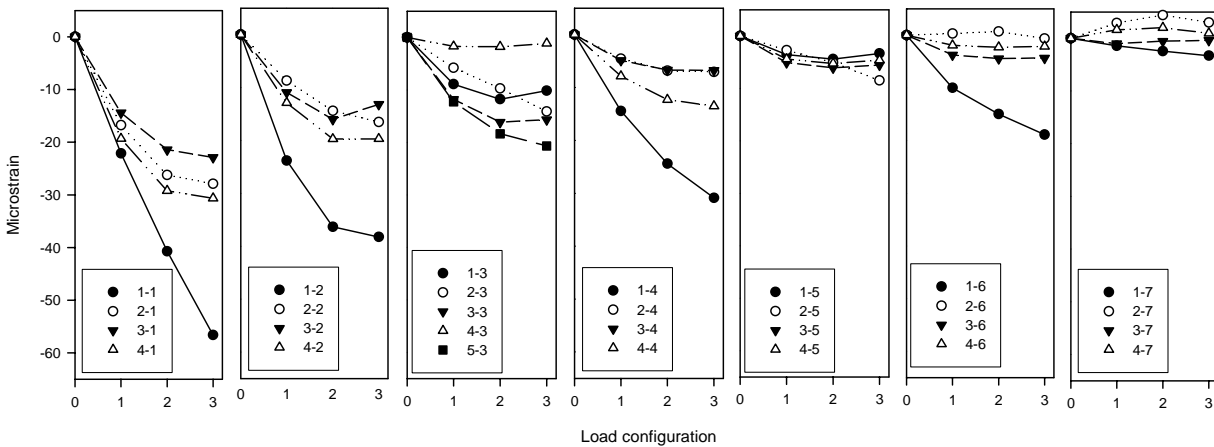
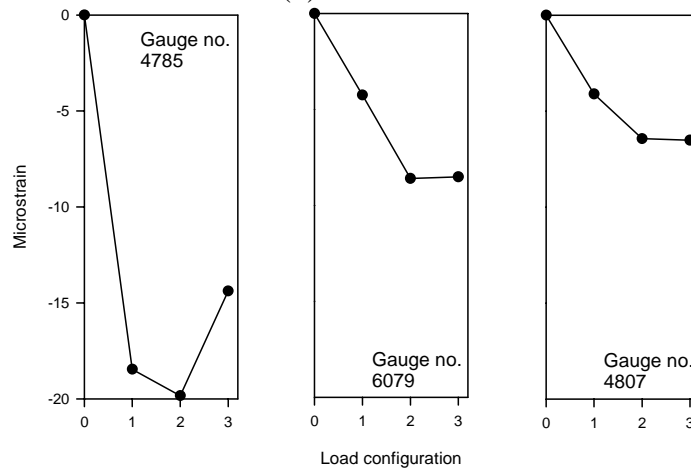
Figure 8.20. Static load test at the east edge (Bridge No. 243470 – Marshall County)

The third test was carried out with the loads positioned at the east edge. The location of the applied axial loads, pile strains, and backwall strains are shown in Figure 8.20. The highest measured strains were directly under the applied load (i.e. pile nos. 1, 2, and 3), and decreased with increasing distance from the location of the applied load. The strain transducer attached over the tie back rod at pile no. 3 indicated negligible strain values. At pile no. 7, strain transducers 2-7 and 4-7, which were connected to the outer side of the pile, recorded positive strain values. The opposing strain transducers 1-7 and 3-7 recorded negative strains.

The strains measured in the backwall showed a non-uniform distribution. Strains were higher at the east side of the bridge directly under the live load and decreased with increasing distance from the load location.

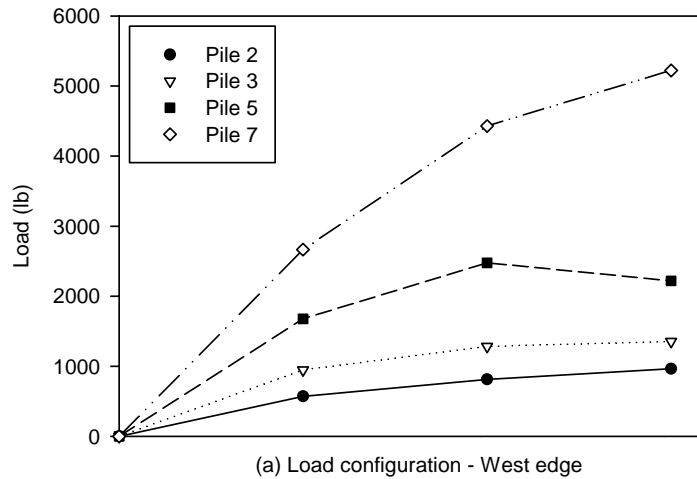
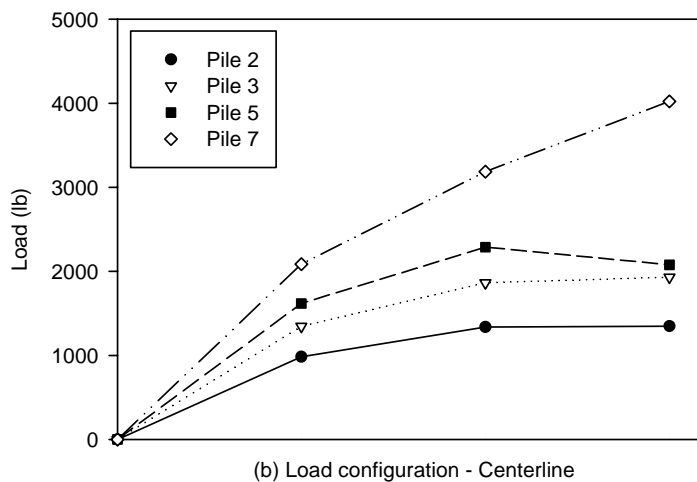
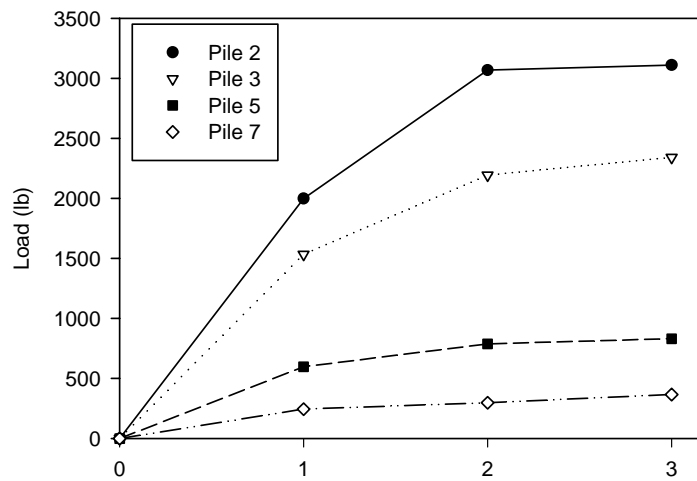
Figure 8.21. Calculated load carried by south abutment piles (Bridge No. 243470 – Marshall County)

The loads carried by pile nos. 2, 3, 5, and 7 in the south abutment were calculated using their measured E and strain values. Table 8.3 summarizes the calculated loads and the percentage relative to the total applied load. When the load was at the west edge, the percent load resisted by pile No. 7 varied from 13 to 15%, which is comparable to the load carried by pile no. 1 in the north abutment. When the load was at the opposite side of the bridge, the percent load carried by pile 7 ranged from 1 to 1.4%. Loading the bridge at the centerline appears to distribute the load more evenly between piles. Pile no. 2 carried about 10% of the load when the load was positioned directly over it. This is also comparable to pile no. 6 in the north abutment where the carried load ranged from 11 to 15%. The load carried by all four piles was about 30% of the total load. Loads carried by the south abutment piles are presented in Figure 8.21.

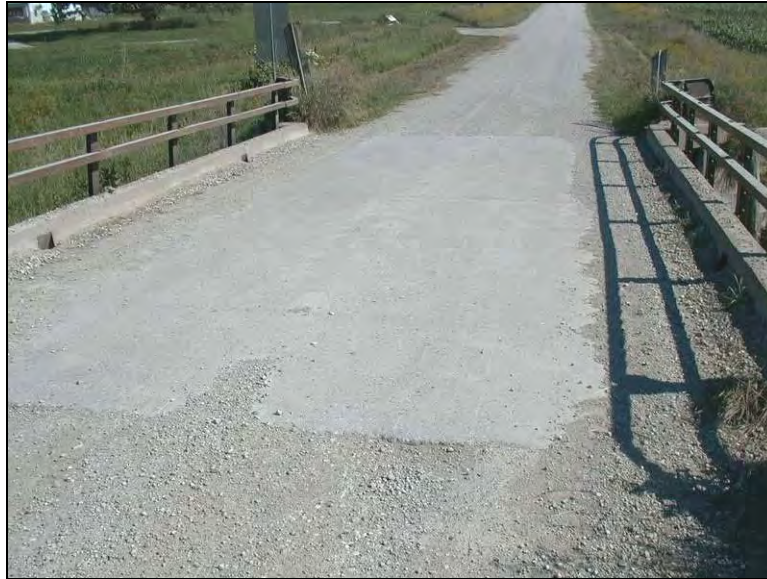
Figure 9.1. Bridge No. 237350 – Looking north (October 25 2005)

This bridge is located in Mahaska County on Rutledge Avenue near Oskaloosa, Iowa. The bridge, which is a single span, is about 33.3 ft long and 17.5 ft wide (See Figure 9.1). The superstructure, which has a 0° skew, has a concrete deck, which is supported on five steel girders. No plans were available for this bridge.

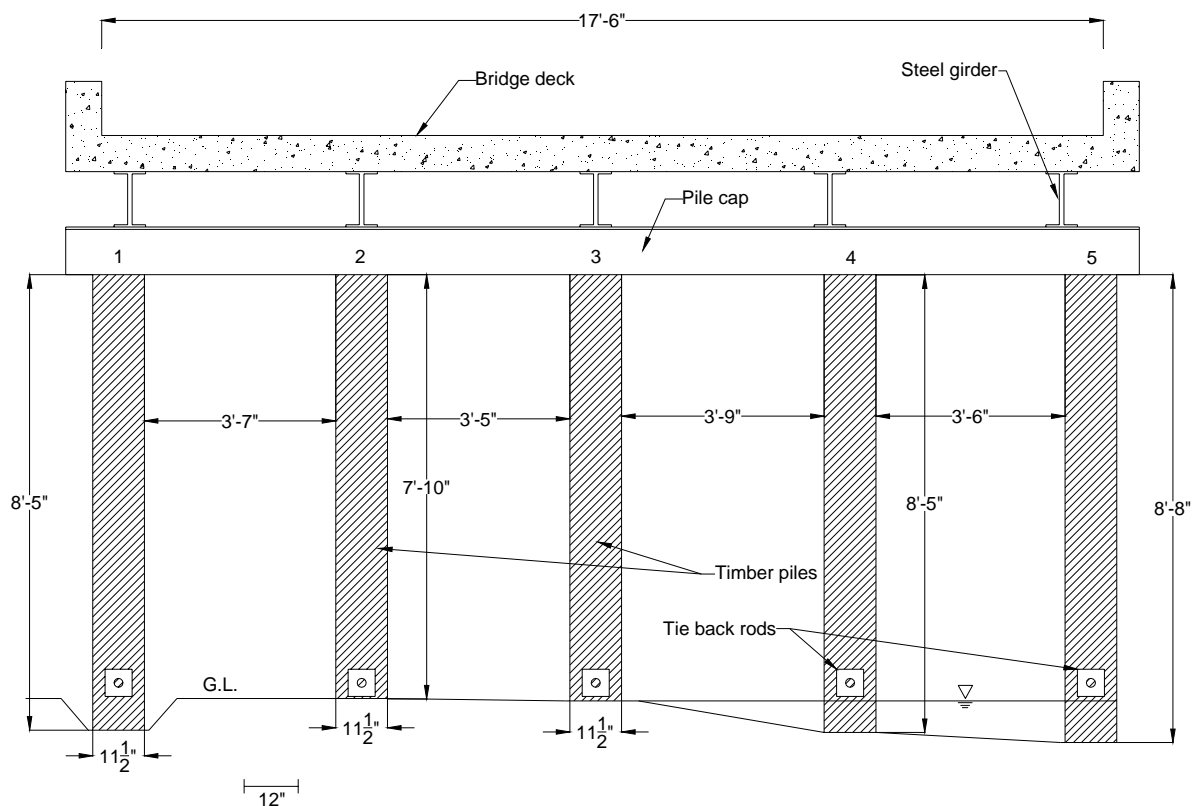
Figure 9.3. Schematic diagram of the north abutment (Bridge No. 237350 – Mahaska County)

Each abutment is supported on five timber piles in front of a timber backwall with two timber piles at each wingwall. The pile cap is comprised of two double c-channel steel sections. The average exposed pile length and pile spacing at the north abutment are 98 inches and 46 inches, respectively (See Figure 9.2). A schematic of the north abutment illustrating the exposed pile lengths, location of girders, pile spacing, and tie back rod elevations is shown in Figure 9.3. The tie back rods are located at a depth of about 94 inches from the pile heads. Since no plans are available for this bridge, the pile lengths and the length of the tie back rods are unknown. Pile no. 1 at the northwest corner of the bridge showed signs of biological deterioration near the ground level as shown in Figure 9.4. Pile no. 5 at the northeast corner of the bridge showed signs of UV degradation as evidenced by the broken wood fibers on the pile surface; this pile also had a soft section near the water level (See Figure 9.5).

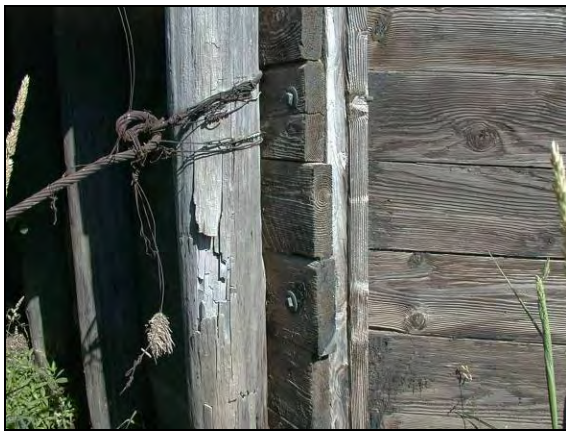
Figure 9.5. Deterioration observed at pile No. 5 (Bridge No. 237350 Mahaska County – October 25 2005)

(a) UV degradation

(b) Soft section near the water level

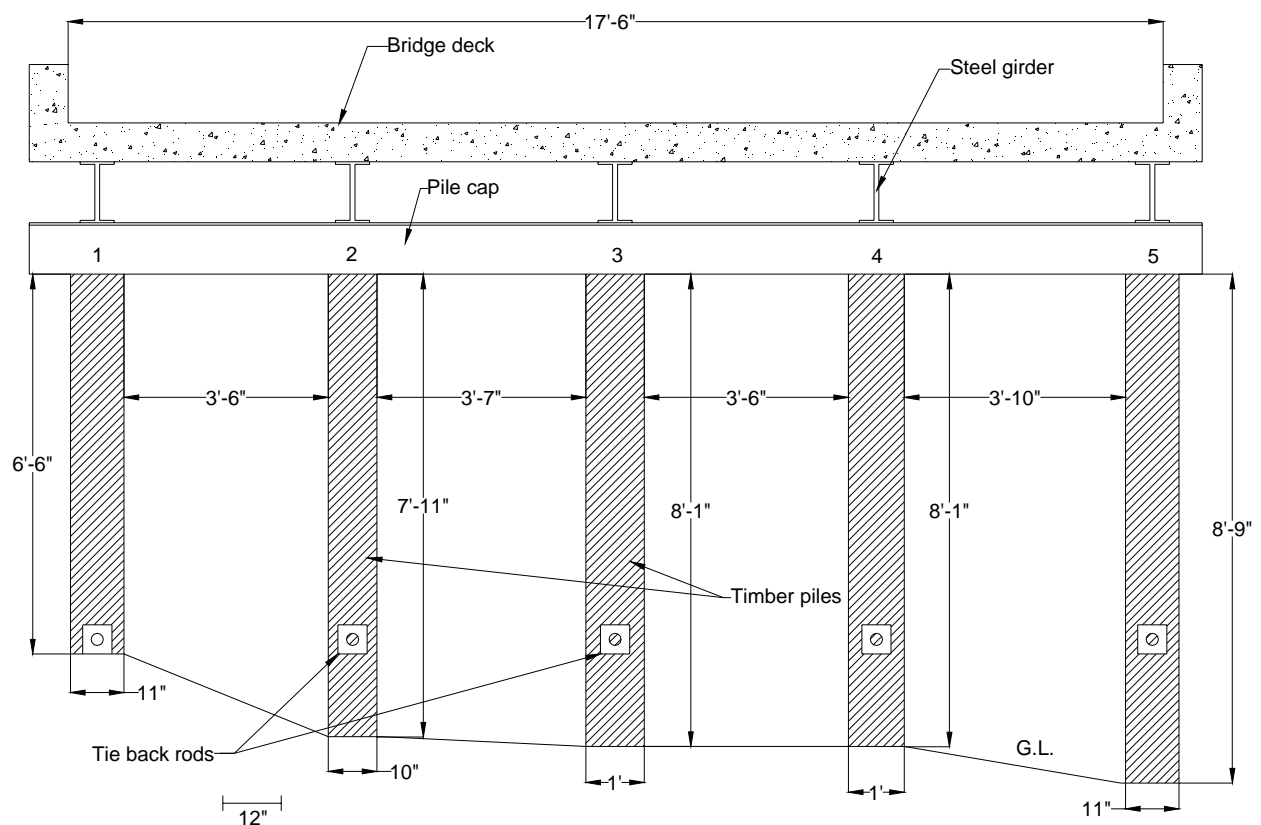
Figure 9.7. Schematic diagram of the south abutment (Bridge No. 237350 – Mahaska County)

The south abutment, shown in Figure 9.6, has an average exposed pile length of about 94 inches and an average pile spacing of 49 inches. The tie back rods are about 6.5 ft from the pile heads. Figure 9.7 is a schematic diagram of the south abutment illustrating the exposed pile lengths and spacing. Visual observation revealed brooming in pile no. 2 near the ground level as shown in Figure 9.8. For pile no. 5, rotting near the ground level was observed (See Figure 9.9).
